Inspection Report Minerals Regulatory Program Report Date: September 29, 2006

Mine Name: Vermillion Mine

Permit number: S/053/076 Date: September 13, 2006

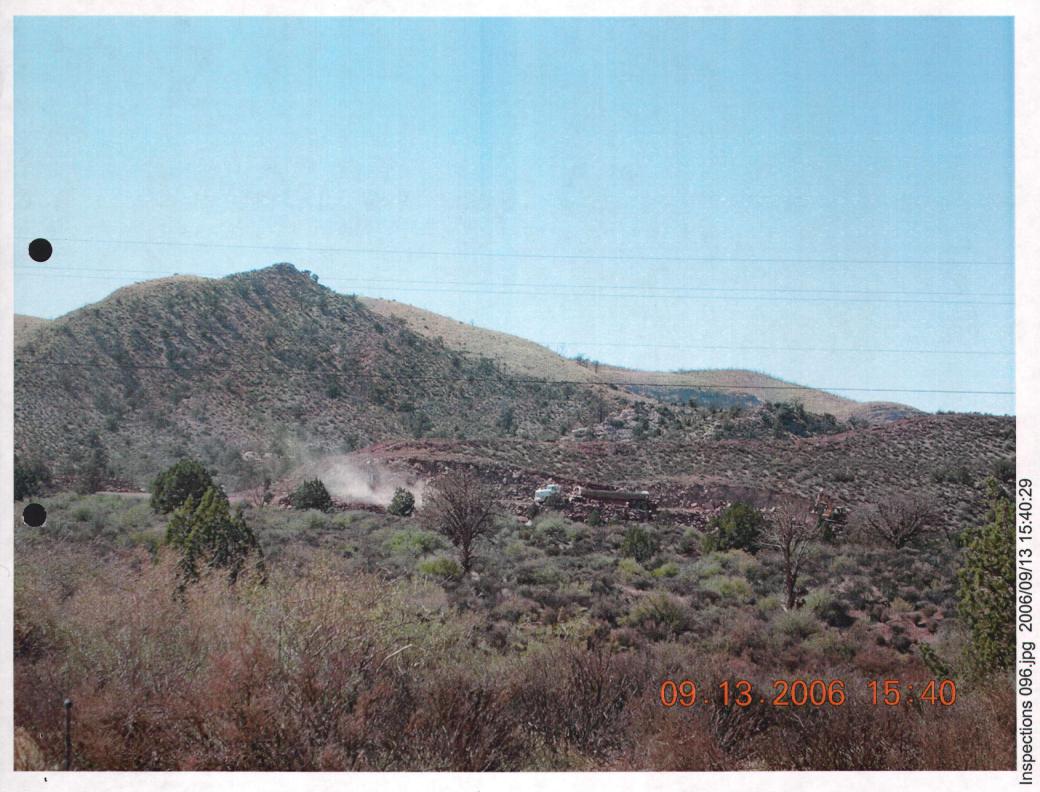
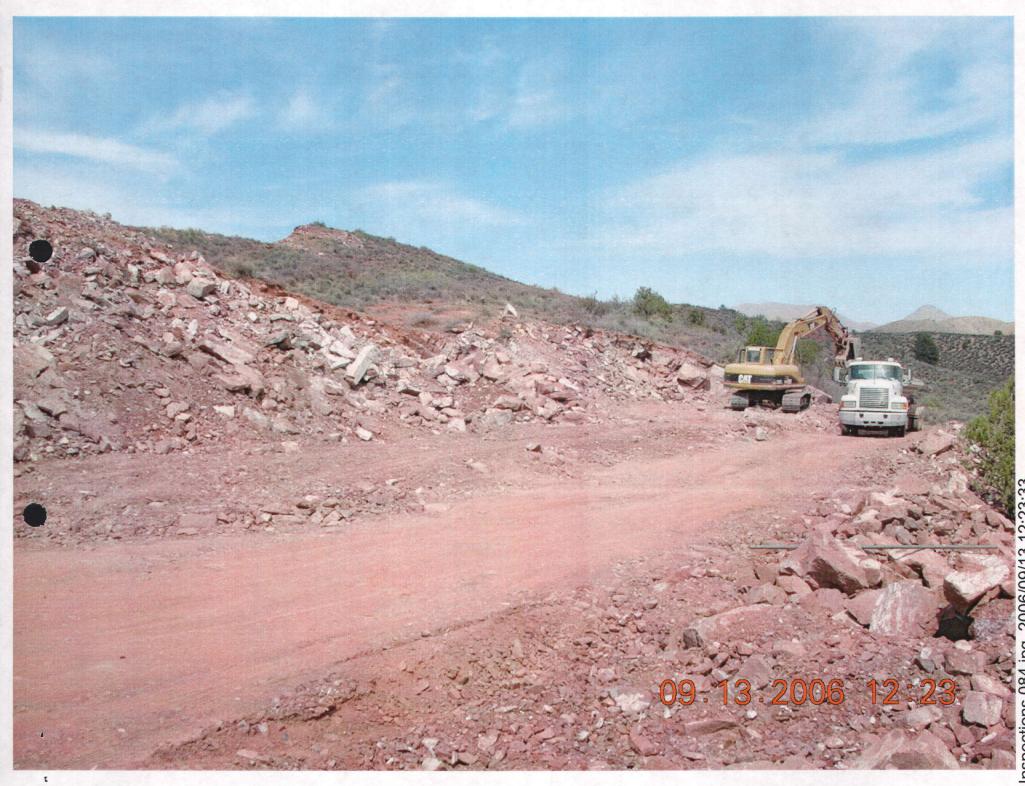
2006/09/13 12: Inspections 084.jpg

CPI was operating at the site removing large boulders. There was a loader, trackhoe and several trucks operating at the site. The rocks were being hauled to St. George.

The area being disturbed was an area in addition to the areas that I gps'd in March of this year. The new disturbance will add about a half an acre to the total disturbance at the site. I did not gps the additional disturbance but will do so during my next visit. Pictures were taken at the site.
